Tube-Based Crossovers

January 2003, p. 60-65 (020297-1).

Small DC-DC Converters

January 2003, p. 54-58 (020180-1).

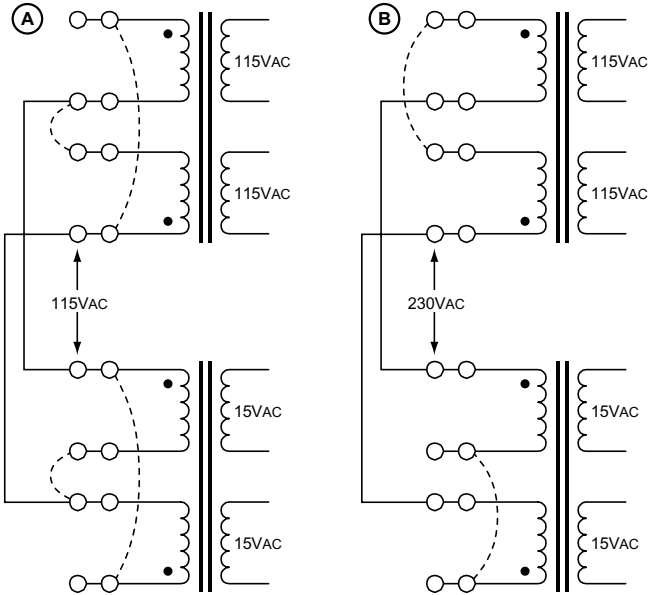
020297- 13

A number of errors have crept into the drawings in Figure 3 on page 61 of the article. In Figure 3a, two unnecessary and possibly harmful wire links are shown, while the labels '115 V' and '230 V' in Figures 3a and 3b should have been transposed. Also, all transformer secondaries should have been marked '115 V', not '15 V'. To prevent misunderstandings the corrected drawings are printed here.
